# Flood Investigation Report

Flooding at Kibworth Harcourt & Kibworth  
Beauchamp  
(Kibworth)  
20<sup>th</sup> July 2021

Final Report

May 2024

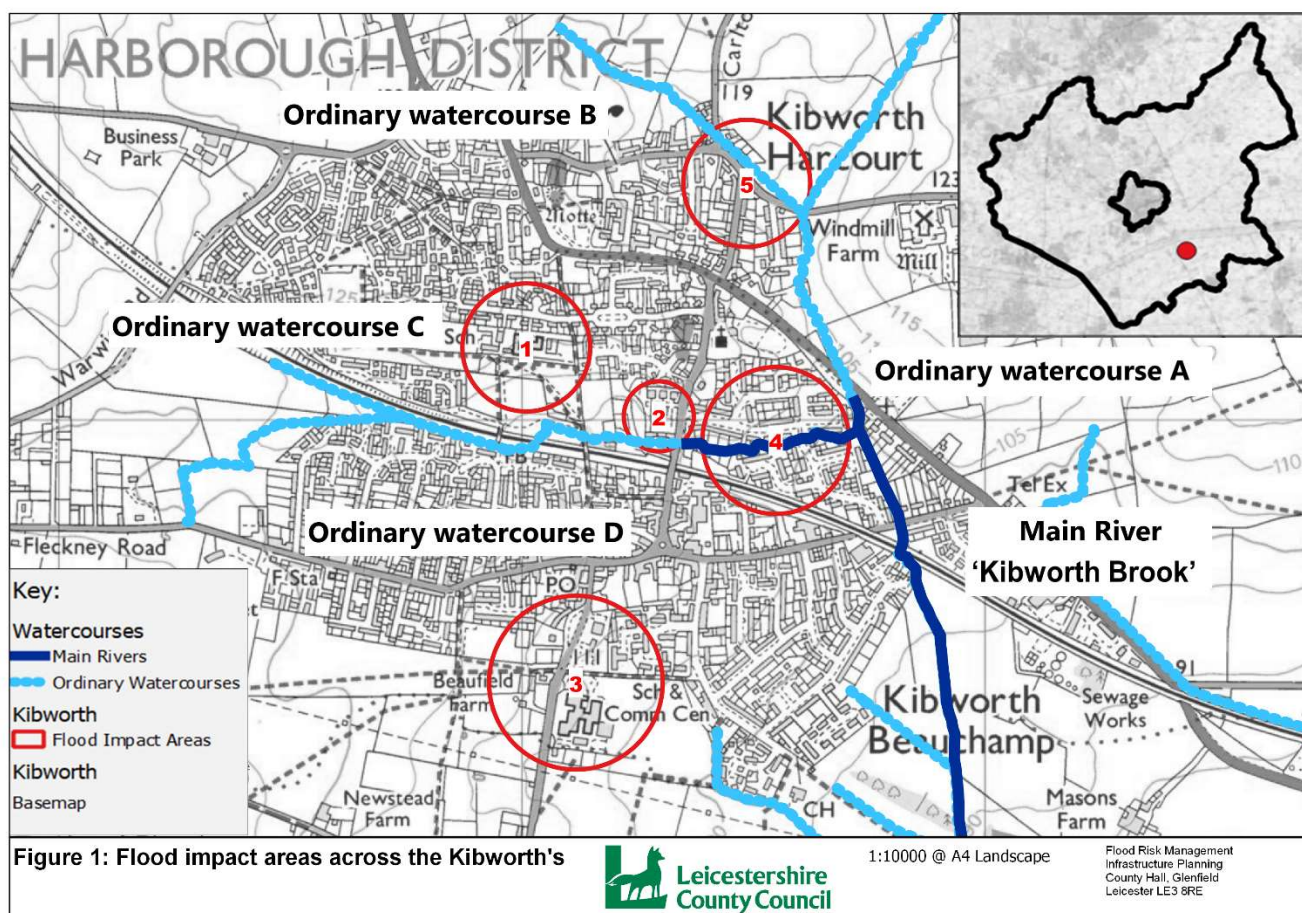
The flooding event which occurred on 20<sup>th</sup> July 2021, impacted five key parts of Kibworth including:

1. Kibworth Primary School
2. Church Road and Station Hollow
3. Kibworth Mead Academy and Kibworth Court Care Home
4. The Lea and Brookfield Way
5. Langton Road

These five flood impact areas are indicated on Figure 1 below.

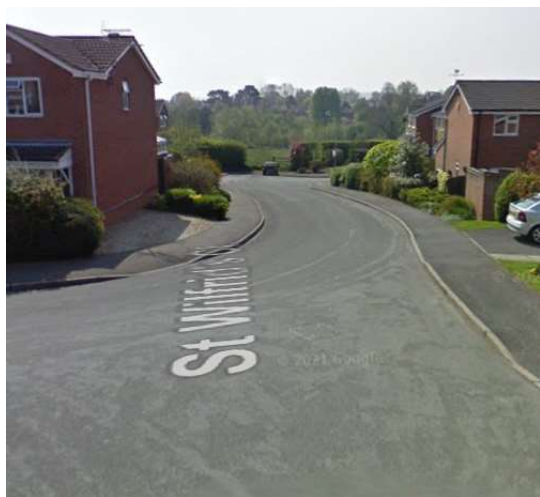
**Photograph 1:** St Wilfrids Close in 2009 showing gradient down to field

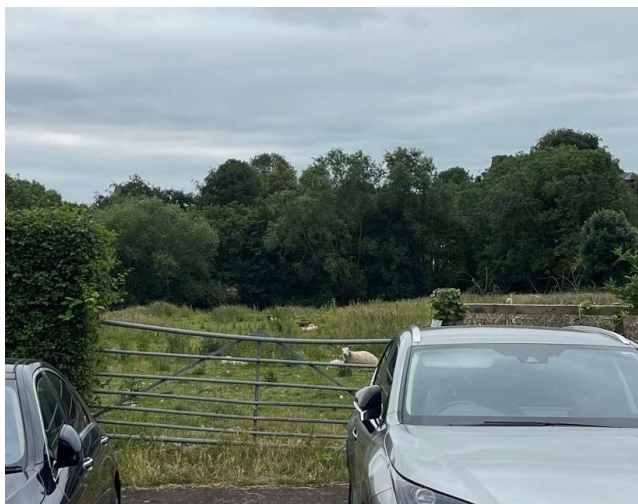
**Photograph 2:** Field at bottom of St Wilfrids Close showing steep drop of field to watercourse C

Further information also suggest that rainwater ran from St Wilfrids Close over agricultural land into ordinary watercourse C. It is clear from the site visit that land slopes towards the watercourse steeply and therefore any surface water run off could easily find its way into ordinary watercourse C during high runoff events, such as the event in July 2021.

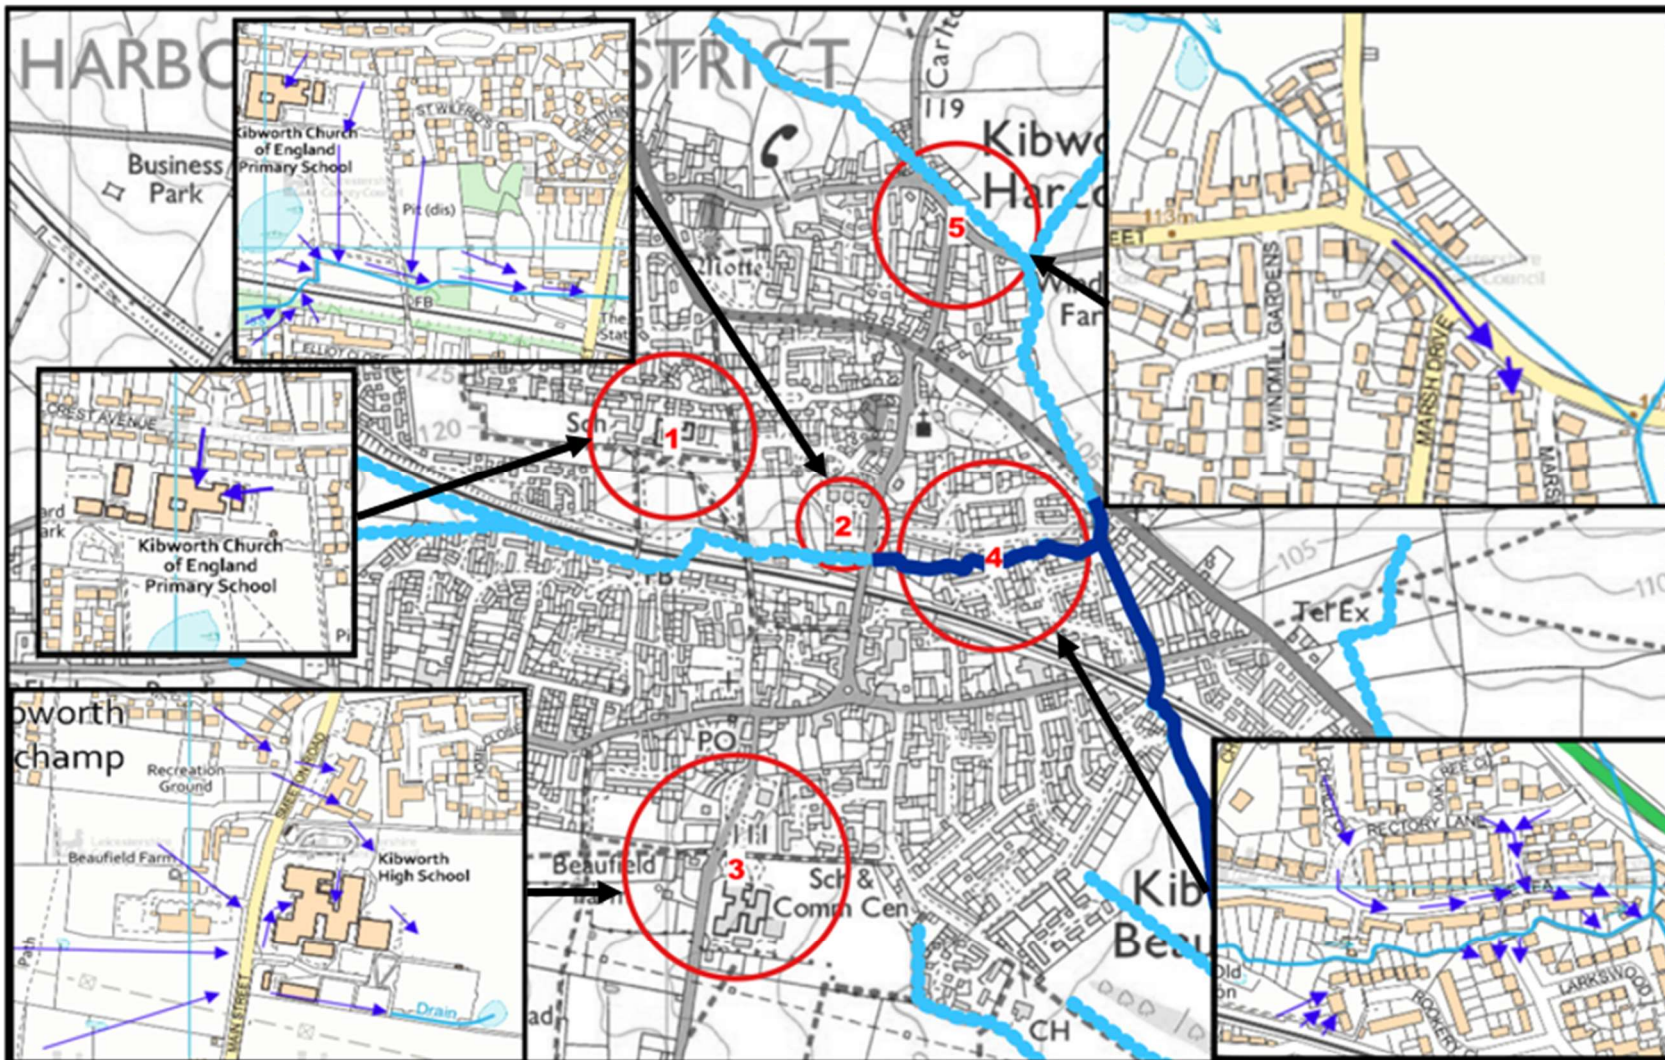
Figure 2: Flood water flow paths

Surface water was described to travel down the highway from the top of Marsh Drive towards residential properties and driveways at the corner of Langton Road (Figure 2). Water which collects at the low point on Marsh Drive travelled through gardens towards the rear of the internally flooded property. Water also overtopped the ditch adjacent to the property and ran towards the private drive of one residential dwelling into the front perimeter of the property. Water was also reported to have surcharged from an Anglian Water inspection chamber located in the driveway of the same property on Langton Road. This water combined with the highway/surface water and entered the property internally via air bricks and the property threshold.

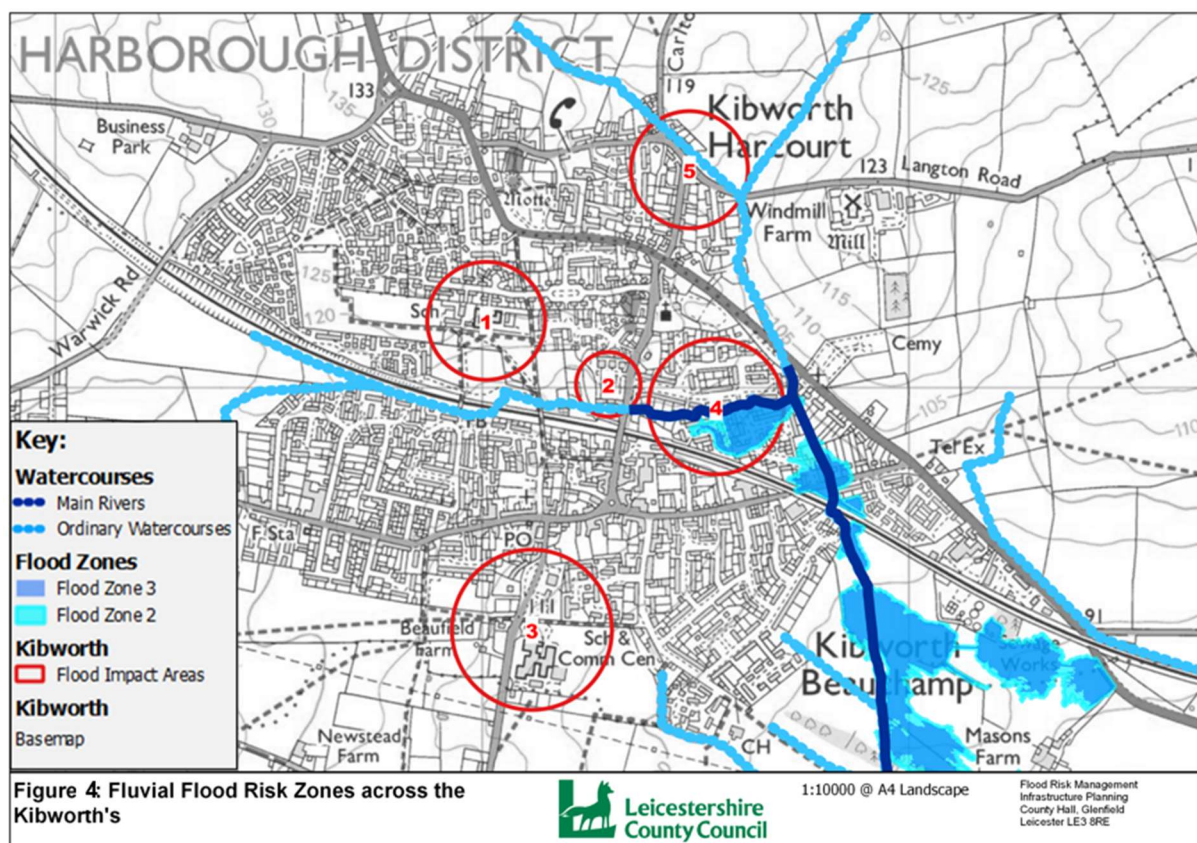
Figure 4 shows the Flood Zones associated with the watercourse. Flood Zone 3 shows the area that could be affected with a 1 in 100 (1%) or greater chance of happening each year. Flood Zone 2 shows the extent of an extreme flood from rivers with up to a 1 in 1000 (0.1%) chance of occurring each year.

All flood impact areas are located within fluvial Flood Zone 1 apart from flood impact area 4 which lies within in Flood Zones 2 and 3. These are based on long term flood risk maps published on [www.gov.uk/check-long-term-flood-risk](http://www.gov.uk/check-long-term-flood-risk). The fluvial flooding that occurred on 20<sup>th</sup> July 2021 in flood impact area 4 is as predicted.

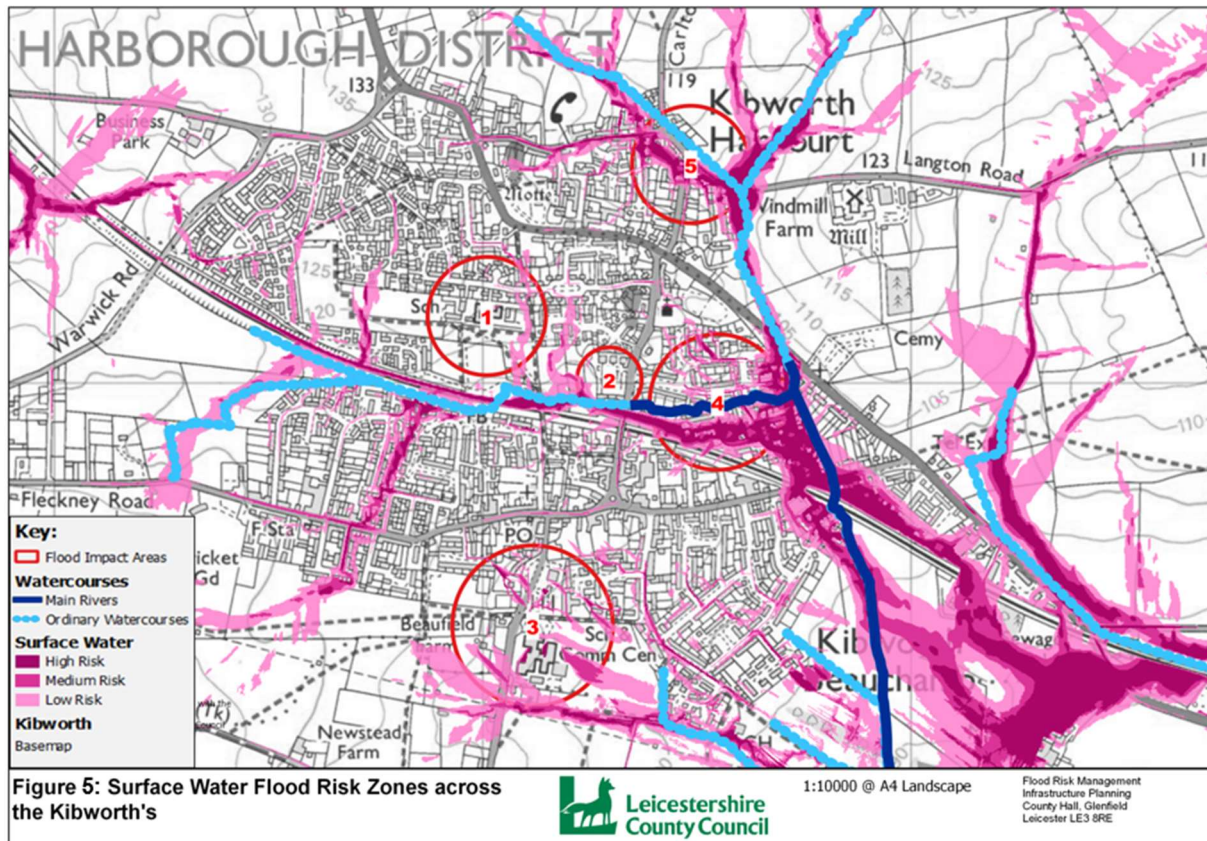
A map of the risk of flooding from surface water (Figure 5) has been produced by the Environment Agency (EA), published on [www.gov.uk/check-long-term-flood-risk](http://www.gov.uk/check-long-term-flood-risk), using high level modelling which represents where water could flow and accumulate during certain rainfall events<sup>5</sup>. Following a review of this mapping it is understood that significant parts of Kibworth are susceptible to surface water flooding including the areas affected during the storm on the 20<sup>th</sup> July 2021. The extent of surface water flooding in each flood impact area and the affected properties identified during the event on 20<sup>th</sup> July 2021 are largely consistent with the surface water flood model extents and flow paths identified in Figure 5 further supporting the theory that surface water was largely the source of flooding during this flood event.

However, there is one discrepancy identified between the surface water flood risk map and flood impact area 1. Figure 5 indicates a low risk of flooding from surface water in this impact area. This does not correlate with the anecdotal information collected from the local community as it is understood this flood impact area suffered primarily from surface water flooding from the car park.

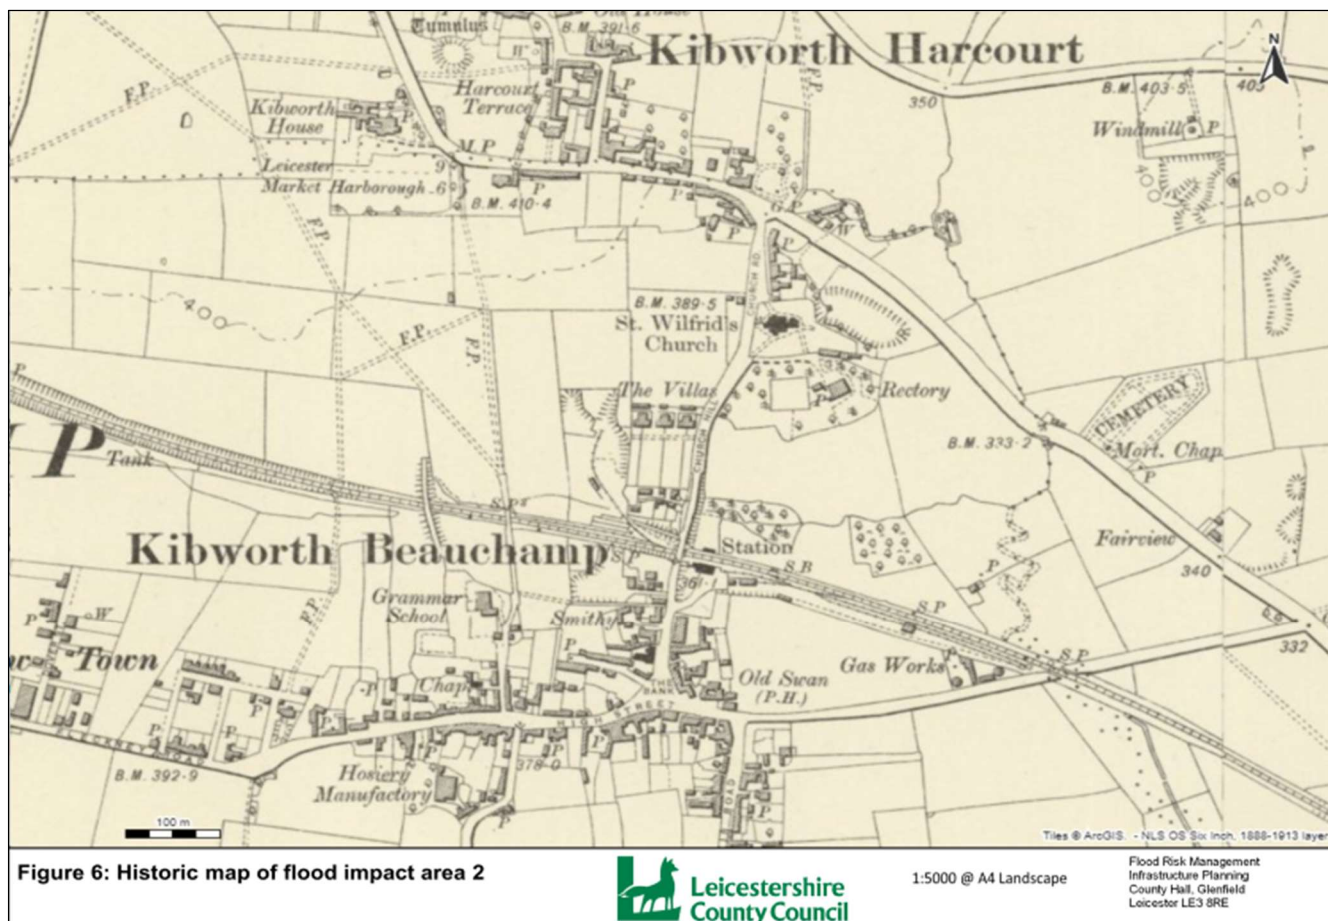
Through engaging with the local community there have been anecdotal reports that Station Hollow was historically quarried for sand and gravel linked to the railway. The properties in this vicinity sit at a low point compared to surrounding land and thus making them more susceptible to flooding. The extension of the railway at Station Hollow can be seen in historical mapping as shown in Figure 6.
